HOW TO IMPROVE INDUCTOR LIFE

Inductors used in induction heating applications operate in a harsh environment including rapid thermal cycling from high temperatures to room temperature and exposure to cooling fluids and process quenchants. Optimizing inductor life under these conditions requires good system preventative maintenance.

William I. Stuehr* David C. Lynch**

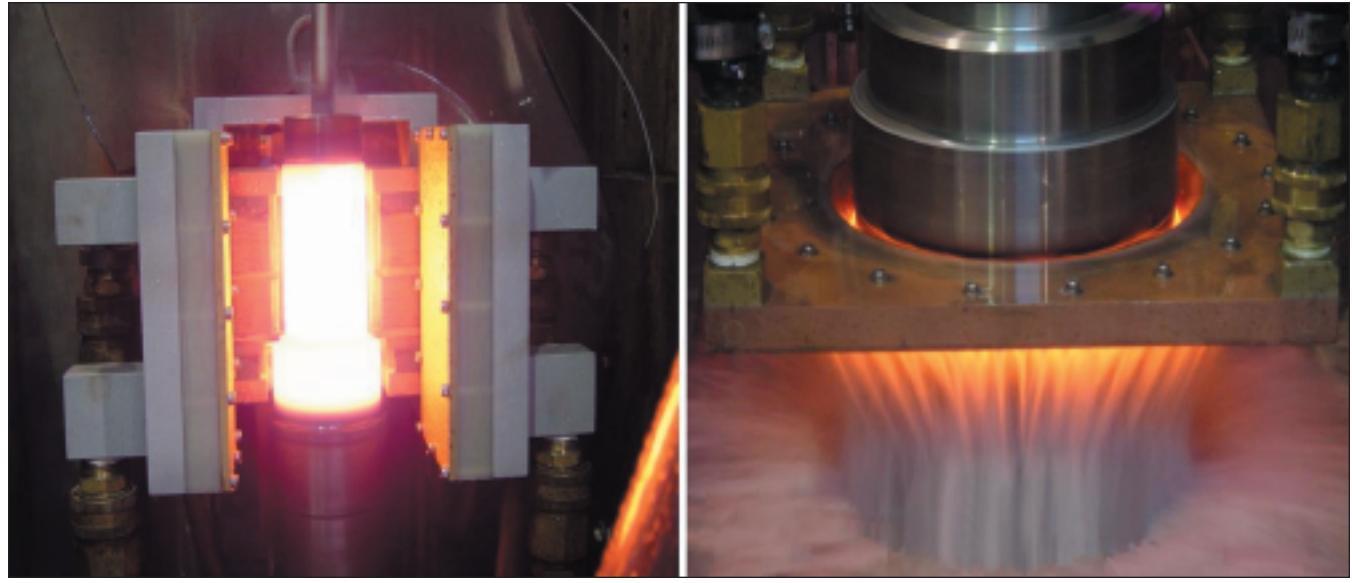
Figure 1 — High-power single shot and scanning type inductors.

mong the many types of inductors used in induction heat treating are single shot and scanning inductors (Fig. 1), which are extensively used in high energy, high production applications. Inductors operate at high frequency and high power in a harsh industrial environment including high temperatures, rapid thermal cycling and contact with various fluids. Getting the most out of an inductor in this environment requires close attention to good system maintenance. Three areas that can have a significant impact on inductor life discussed in this article are electrical contact maintenance, inductor cooling, and quench maintenance.

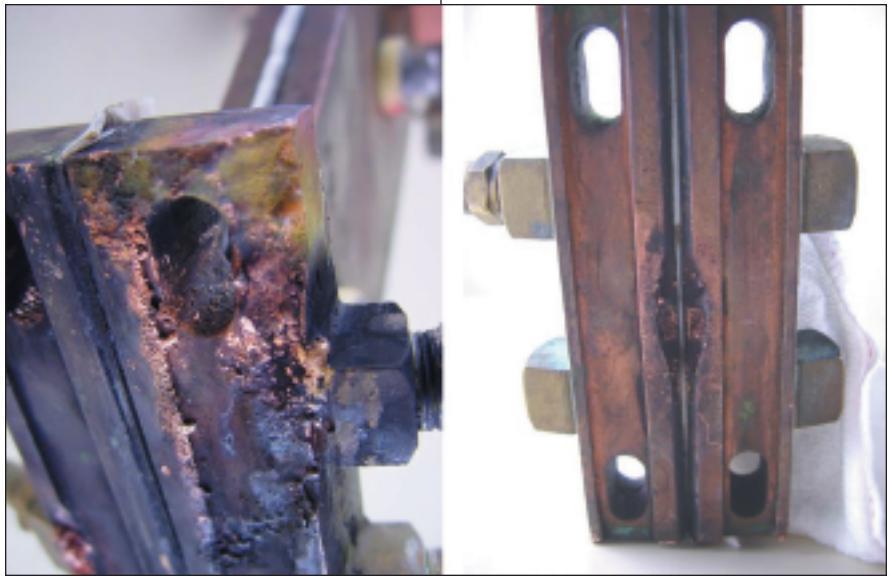
Figure 2 — Arced contacts due to improper or loose bolts (left) and an accumulation of dirt (right)

The initial point of electrical contact in the system is where power is introduced to the inductor from the output transformer. Often, the inductor is bolted directly to the transformer. Sometimes bus extensions and inductor adapters are used, which involves several additional points of electrical contact. Each of these contacts must be kept clean and properly bolted to prevent damage to the contact area. Figure 2 is an example of what can happen to an improperly bolted contact. Arcing caused by a damaged insulator (seen at the right side of the photo) occurred across dirt accumulated over time. The resultant arcing caused extensive damage not only to the contact, but also to the transformer mounting foot, requiring replacement of the transformer.

Inductor contacts can be cleaned using a nonabrasive pad (e.g., such as those used in the kitchen), soap, and water, then silver plated, which prevents oxidization. Steel wool pads should not be used because steel residue from the pad may cause arcing. Contacts should be plated when the inductor is replaced.

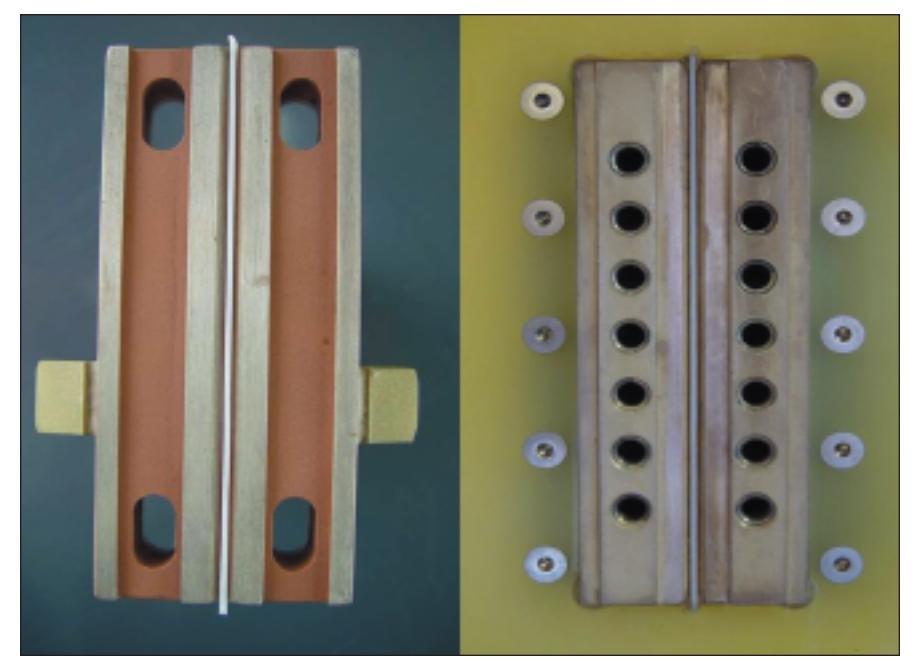
Figure 3 — Clean, silver plated transformer and inductor contacts

Figure 3 shows well-maintained inductor contacts.

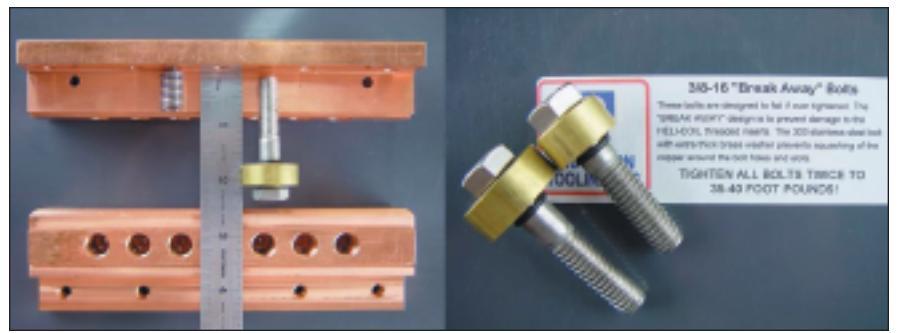
Figure 4 — Break-away bolts and washers

Properly bolted contacts require the use of both a proper bolt and washer (Fig. 4). Threaded inserts in the foot should be inspected for damage before installation to the transformer foot. Tapped holes in the transformer foot often are not drilled through, therefore the threaded hole depth should be measured using a pencil point. Using this measurement, the bolt must be shorter than the sum of the contact thickness and the total hole depth. The bolt must fully engage the threaded insert (usually 0.375 to 0.5 in., or approx. 10 to 13 mm) and tightened to 155 or 178 N (35 or 40 ft. lb.)Because over-tightening can cause damage to the threaded insert, special break-away bolts are available, which are designed to snap the head at 245 N (55 ft. lb.) preventing thread damage and allowing easy removal of the remaining stud. Special thick washers (shown at the right of Fig. 4) work with the bolt to protect the copper by distributing the compressive load. Further protection is provided over slots by means of specially designed integrated washers. Steel bolts and washers should never be used in an electromagnetic circuit.

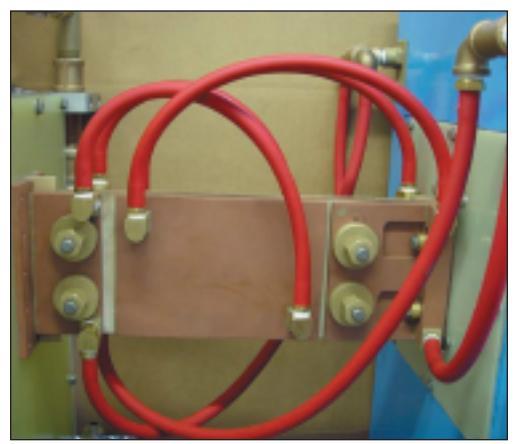
Figure 5 — Transformer is kept out of the working environment of the induction heating process using an interconnecting bus bar.

Preventative electrical contact maintenance is further achieved by isolating the power transformer from quench fluids, oil, smoke and dirt. This can be accomplished by moving the transformer back and out of working environment (if possible). Figure 5 shows the installation of a new panel with an inductor

mounting foot and a short bus back to the repositioned transformer. The benefit is two-fold: 1) damage to the mounting foot on the panel can be immediately repaired or replaced using inexpensive parts; and 2) it eliminates the possibility of a costly transformer breakdown caused by quench fluid and dirt contamination.

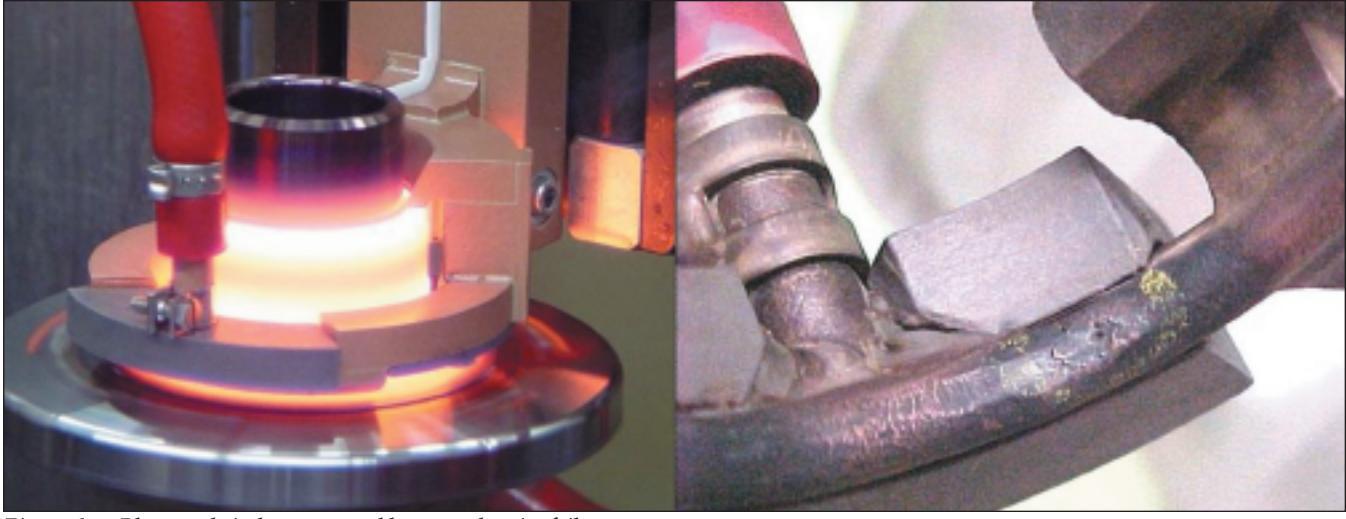
Figure 6 — Blown axle inductor caused by steam barrier failure

Figure 6 shows a blown inductor in a wheel axle spindle due to a steam barrier failure. Fillet and flange heating require intense energy (exceeding the current limit of the copper conductor) for short periods. In this case, a cooling water pressure boost to 200 psi (14 bar) directly into the cooling chamber could not prevent a steam vapor barrier from forming. There is an intense current flow within the copper closest to the steel part being heated due to the proximity effect. The intensity of current causes the cooling water to immediately vaporize along the current path inside the water chamber, causing the formation of a thin steam

vapor barrier, which does not permit the copper to cool. The cooling water simply flows over the boiling vapor surface, resulting in a rapid increase in electrical resistance, causing the copper to heat and expand locally. These localized hot spots expand, contract, and oxidize during each cycle leading to failure. Flux intensifiers, although essential to the process, aggravate this condition.

Inductor life can be improved by forcing cold (50 to 70°F, or 10 to 20°C) water into the cooling passages. The electrical resistance of the copper is kept low for a period just long enough for these short cycle (usually 5 seconds or less) heating applications by cooling the copper and replenishing it at 180 to 200 psi (12 to 14 bar). Internal vaporization is delayed within the cool mass of the inductor.

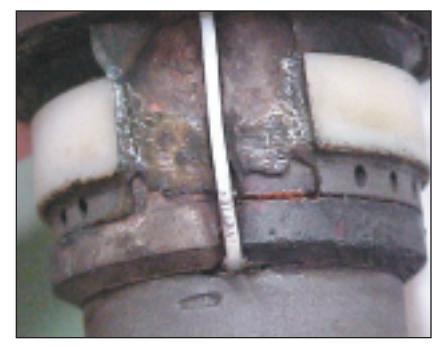
Figure 7 — Blown wheel bearing inductor caused by vapor lock failure

Figure 7 shows a blown inductor in a wheel bearing inductor due to *vapor lock failure*. The inductor is split in half, usually at a braze joint, which is the weakest link because the melting point of the joint material is lower than that of copper. A vapor lock occurs when cooling water boils within the cooling chamber, where it quickly expands and completely blocks the flow of cooling water. Re-

sistance heating within the steam pocket melts the inductor at a weak point. Insufficient pressure to properly cool the inductor is the problem. Assuming the pumping system is working properly, a supply valve may be partly closed or a blockage may be restricting the system. It is also possible that the pressure differential is not low enough to provide adequate cooling flow. Pressure gages should be installed on the water supply and return of the inductor cooling circuit. The cooling system should be inspected before installing a spare or repaired inductor.

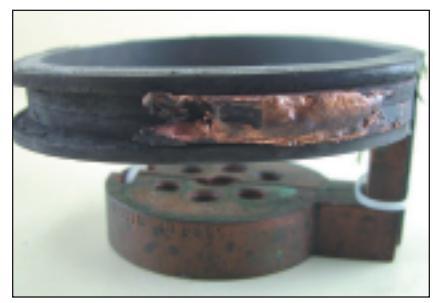
Figure 8 — Blown bore liner inductor due to absence of cooling

Figure 8 shows a blown inductor in a partially disassembled bore liner inductor due to *absence of cooling*. The copper inductor instantly vaporized when a 450 kHz power supply was turned on because the cooling valves to the inductor were closed. Melting occurred so quickly that the flux intensifier material surrounding the tube remained intact. A flow sensor in the inductor cooling line would have prevented the failure.

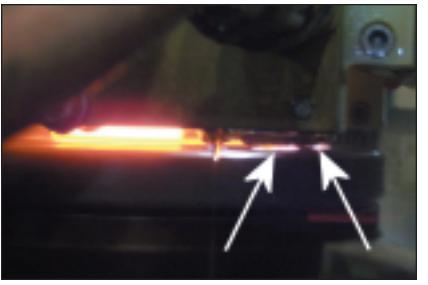
Figure 9 — Arcing (arrows) at the inductor through the quench fluid

Arcing initiating through the quench fluid when the induction power is on is even more dangerous. Many applications require quenching a steel part immediately after heating it (single shot). The next steel part is positioned within the inductor, which is coated with quenchant fluid dripping from the inductor. Because the electrical circuit of the inductor is isolated and operating at a voltage potential to ground, small arcs discharge from the inductor through the dripping quenchant to the heating part (Fig. 9). Arcing continues as parts are processed, removing copper from the area where the arcs occur and eventually eroding the inductor to failure (Fig. 10). This situation often is wrongly blamed on poor cooling or inferior copper.

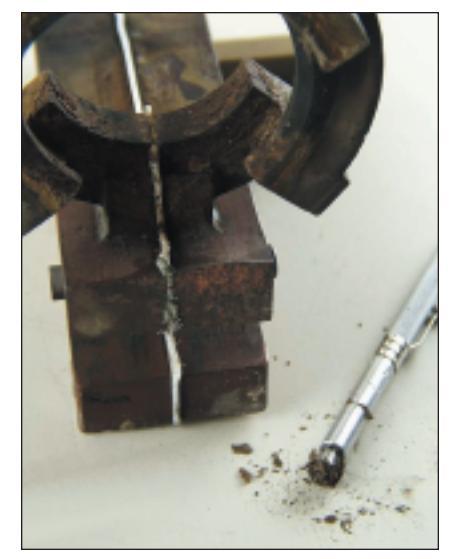
Figure 11 — Inductor coated with magnetic steel particles

The cause of this type of arcing is contamination of the quenchant with fine metal particles of about the consistency of copy toner. The particles enter the induction hardening environment clinging to the slightly magnetic steel parts. The particles electromagnetically jump from the steel part to the inductor when the inductor is powered (Fig. 11). Most are washed off during the quench process, passing through the filters and suspended in the quenchant, accumulating until the voltage potential is right and arcing begins.

Inductor life can be improved under this condition by aggressive parts washing prior to induction heating. Installing a magnetic particle separator in the quench system also is helpful; drum type magnets that work continuously are the best. Magnets in the filter housing work well as long as they are cleaned daily. A simple, large, strong plastic coated permanent magnet suspended in the quench tank also will work in a pinch.
